Redesign of Thresher Machine for Farmers Using Rapid Upper Limb Assessment (RULA) Method

Nilda Tri Putri¹, Lusi Susanti², Anugrah Tito³ and Agus Sutanto⁴

^{1,2,3}Department of Industrial Engineering, Andalas University, Padang, Indonesia

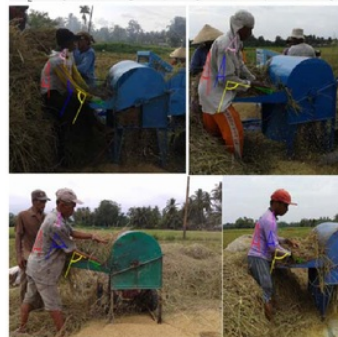
Fig 1 Thresher machine use

It can be seen in the Figure 1. Figure 1 shows the farmers positions operating the thresher machine. However, according to Figure 1 it can be seen that the farmers position when operating the thresher machine was prone to cause musculoskeletal disorder (MSD) problem.

The farmers' work using thresher machine could also lead to musculoskeletal matter as the working positions were constant. Besides, the body's position while operating thresher machine was leaned and straightness when the body's position slightly bended down. It could be clearly seen because the farmers' back formed an angle, and did not stand straightly towards the thresher machine. Besides, the farmers' legs also did not straightly stand as the farmers needed to keep the balance the machine height towards the standing position while operating the machine. Once the farmers straightened the legs, they had to bend down to balance the machine position as well as the body's position.

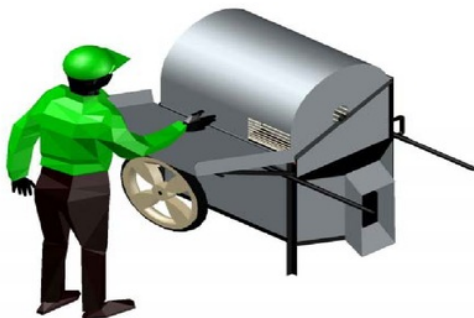
Fig. 2 Thresher Machine

RULA accumulation result above shows that a treatment was required to be undertaken to decrease RULA risk level to the farmers operating thresher machine. A treatment commenced was modifying the thresher machine in order to neutralize farmers' working position. Figure 2 until Figure 4 shown the redesign of thresher machine which can be executed.

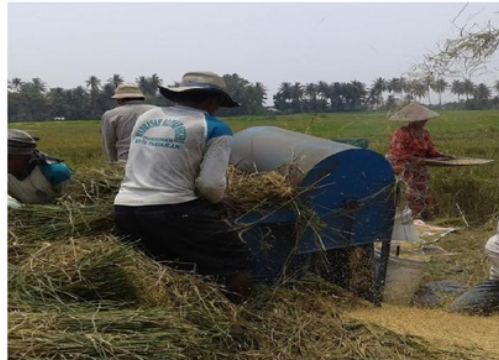
Fig. 5 the Placement of the Thresher Machine

towards the farmers' body. The following Figure 5 shows inappropriate thresher machine placement.

The risk level obtained was caused by farmers' working position which was prone to not ergonomic and the machine condition was incompatible to the farmers' working position. The angle created by the farmers' body while operating thresher machine tend to result higher RULA score; as the consequence, it caused bad impacts
